### FAILURE ANALYSIS OF HP40-Nb MODIFIED PRIMARY REFORMER TUBE OF AMMONIA PLANT \*

S. A. JENABALI JAHROMI \*\* AND M. NAGHIKHANI

Dept. of Material Science and Engineering, School of Engineering, Shiraz University, Shiraz, I. R. of Iran  
Email: Jahromi@shirazu.ac.ir

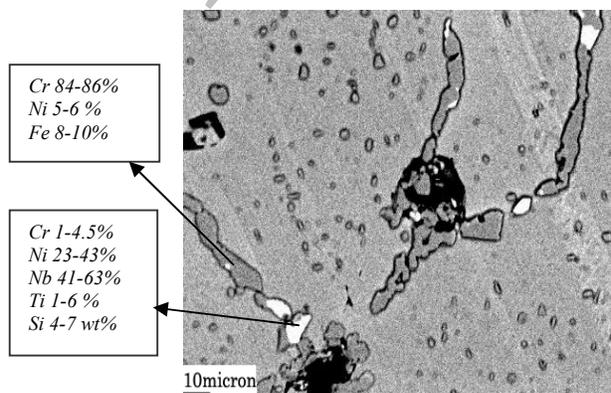
Figure 1 shows the SEM microstructure of the damaged material. The figure shows niobium and chromium rich carbides in the grain boundary in the damaged part of the tube. Grain boundary voids are shown in the optical microstructure. Appearance of the void indicates the occurrence of creep and grain boundary deformation phenomenon in the tube [5]. The various phases were analyzed (Fig. 1).

Fig. 1. Back scatter SEM photo of dominant phases in grain boundary. Dark phase is chromium rich carbides, light phase is niobium rich carbides

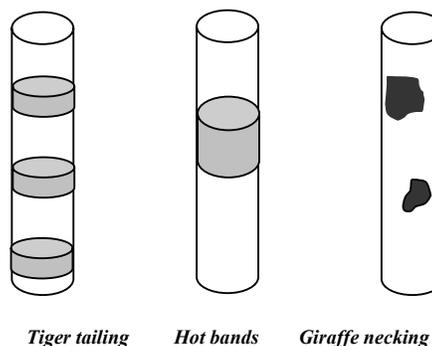
It seems that catalyst plays key role for developing several forms of overheating in the tubes. Several typical forms of overheated tubes are shown in Fig. 2 [6].

Fig. 2. Forms of overheated tubes [6]
