DESTRUCTIVE EFFECTS OF THE 2003 BAM EARTHQUAKE ON STRUCTURES

S.M. Zahrai* and M. Heidarzadeh

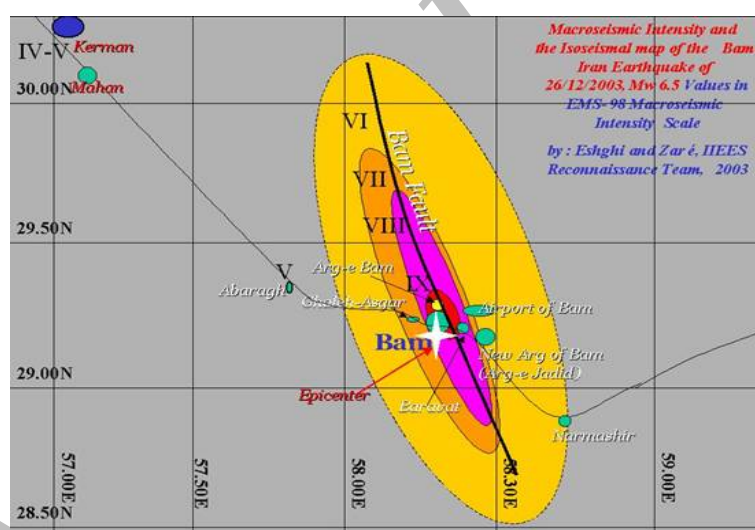
Figure 1. Intensity map of the damaged area [1]

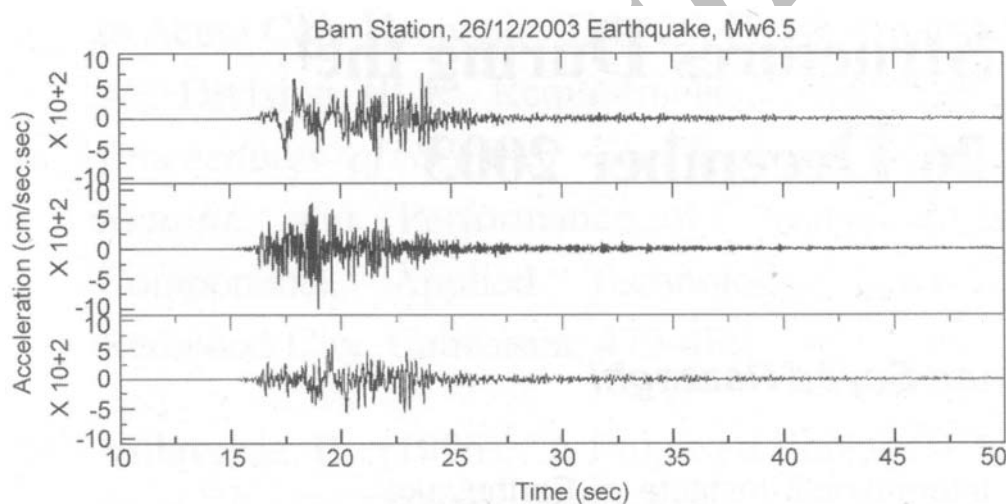
Figure 2. The accelerographs of the Bam earthquake

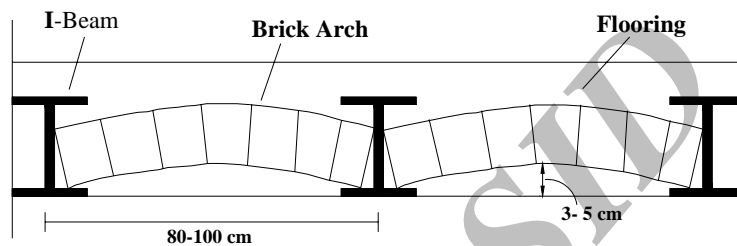
Figure 3. Schematic view of brick jack arch slab typically found in the region

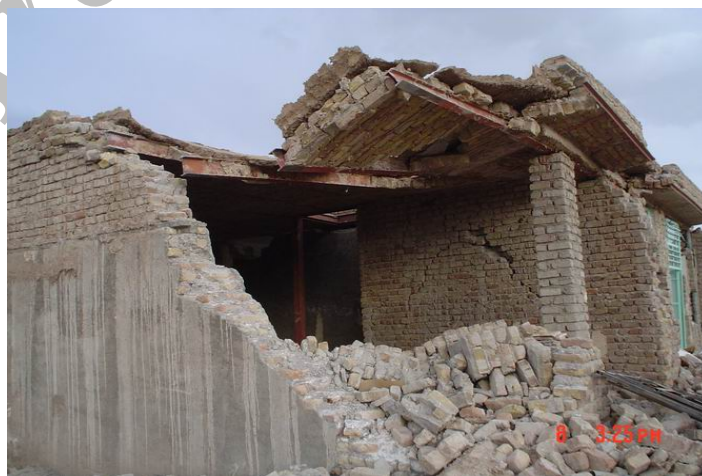
Figure 5. Shear failure of walls, separation of walls from the roof, and separation of roof beams from each other are observed in typical brick buildings

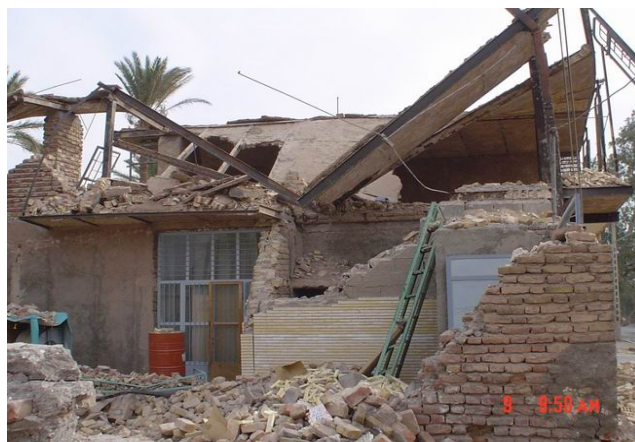
Figure 7. First group of steel buildings, combination of steel internal columns and load-bearing external brick-walls

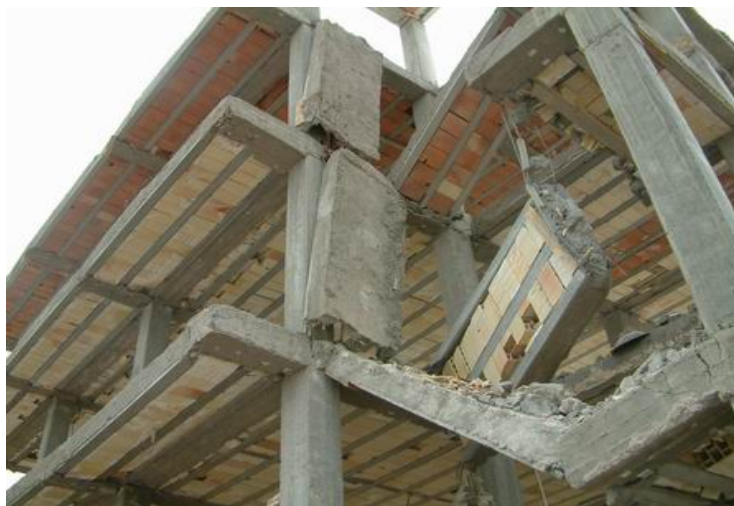
Figure 11. Poor performance of stairs in reinforced concrete structures

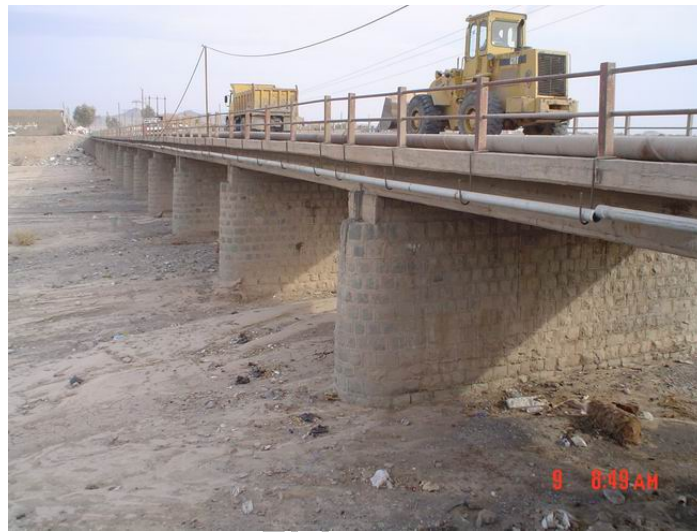
Figure 16. General view of the multi spans Reinforced Concrete Bridge after the earthquake which is in good condition and of course under service.

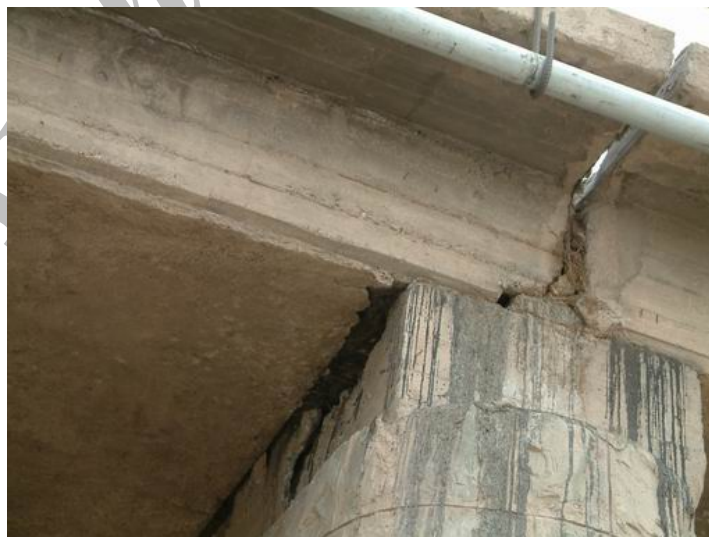
Figure 17. Separation of bridge Spans from the abutment
