Natural Disasters and Diagnosis of Man-made Factors, the Cases of Manjil and Bam

Mohsen Sartipi, Ph. D.

Abstract

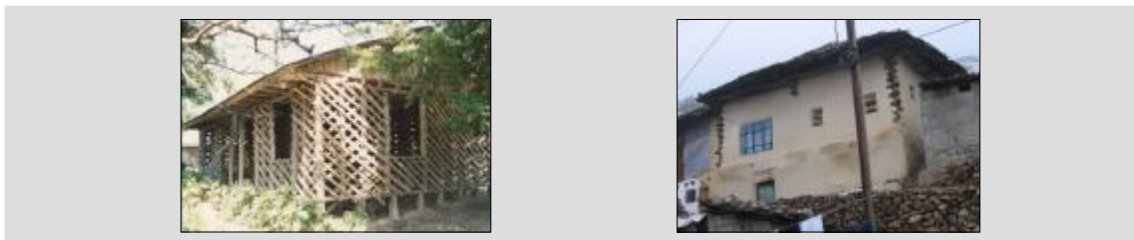
Figure 1- Two buildings with the above-mentioned structures: *Zagme'ee* or *Kal be Kali* houses (on the right) and *Zagali* houses adopted a building system which enough resistant against the earthquake.

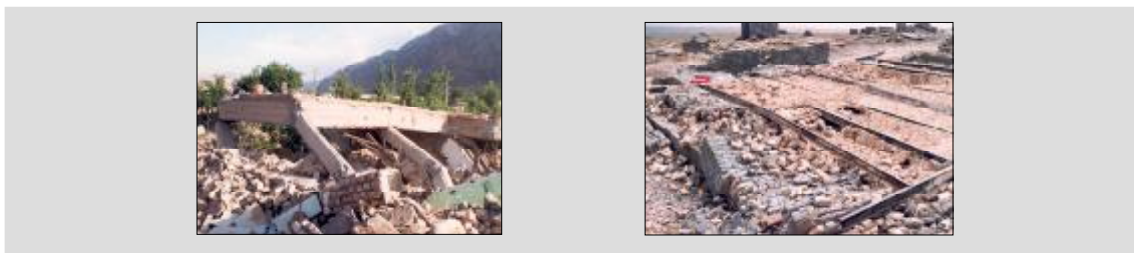
Figure 2- The heavy concrete ceilings and iron beams not connected at he vaulted ceilings are among the most important defects of new construction methods.

Connection breakage in brick barrel-vaults had resulted in the increase of damage. In this case, the connection between walls is lacking with a low rise (of 2 to 3 centimetres) in the section of the steel profiles about one meter from another. In other types of buildings constructed with horizontal and vertical ties and bracing, where execution details of connection, the quality of sand and grit used in the concrete and the ratio of section of steel to concrete had been observed, the building had demonstrated a better performance during the earthquake (Mimar, 1990). The buildings with steel and concrete structure were destroyed primarily on the joints between beams and columns. In steelwork structures most damage seems to have been inflected to welded connections, and in structures with concrete footing beam or frame damage seemed to be caused by unauthorized decrease in the amount of cement, using unsuitable sand and grit, high ratio of water to cement, use of plain bars, decreasing the amount of steel used, ignoring recommended distance between bars and decreasing the number of stirrups.

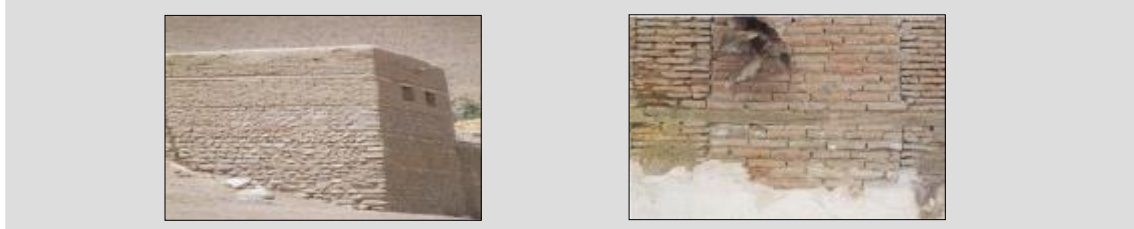
Figure 3- Picture on the right: The use of horizontal logs for strengthening walls with construction materials is a solution for increasing the building stability and resistance. Picture on the left: A rural house made of stone pieces with suitable joints at the corners with the rest of the stones lying in an oblique and regular manner (wedged left and right) with each row on top of the other

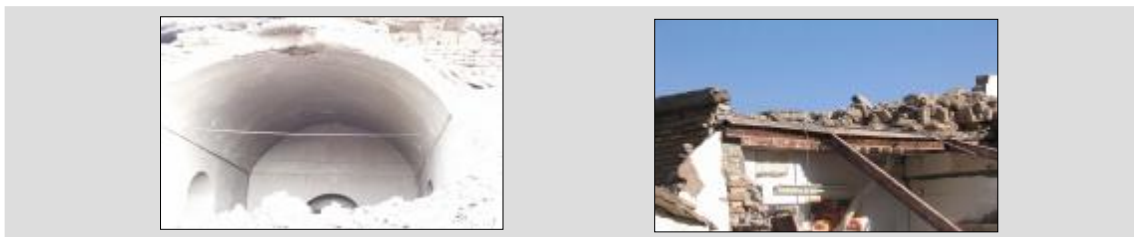
Figure 4- Comparison of stability of steel barrel-vaults and the vaulted-ceilings of mud-brick in Bam Earthquake, and the effect of relative amount of walls

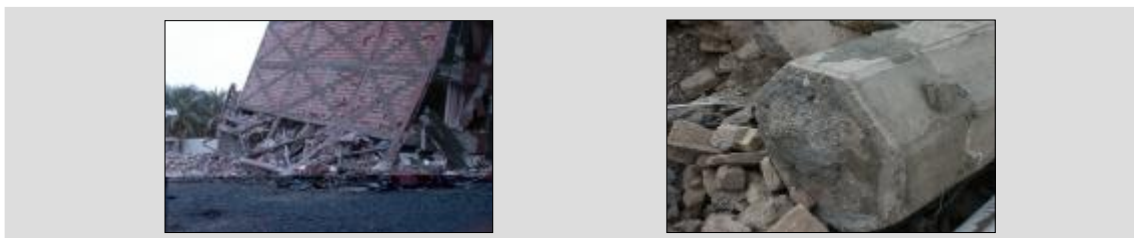
Figure 5- Use of steel below the standard amounts in concrete structures, lack of connection of columns with the foundation, and omission of wind brace in steel structure and the formation of soft storey

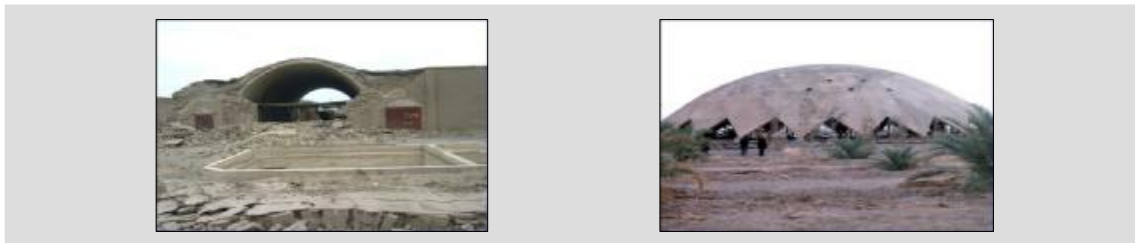
Figure 6- The effect of a geometrical form of the building on its stability, the right picture: a fair hall with the ceiling of space structure and a one-layer coating in newly repaired Arge Bam. The left picture: a mill building with annular barrel vault with a span of 10 meters.

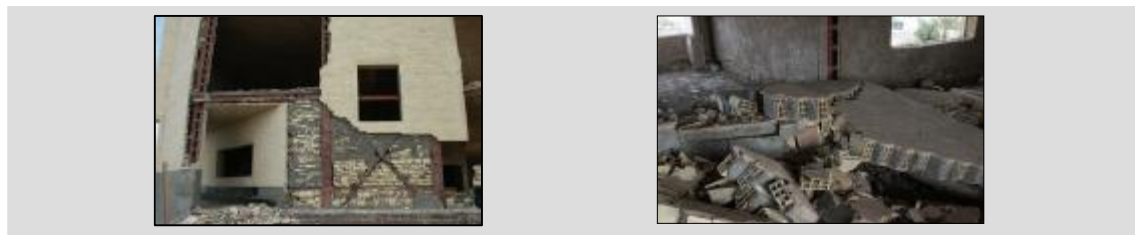
Figure 7- Following the earthquake, many housing and administrative buildings collapsed before the operation phase due to lack of connection between facades and dividing walls, and the structure.
