# Repair and Retrofit of Concrete Columns with Fiber Composites

Mohammad R. Ehsani, Ph.D., P.E.  
Department of Civil Engineering and Engineering Mechanics  
University of Arizona  
Tucson, AZ 85721

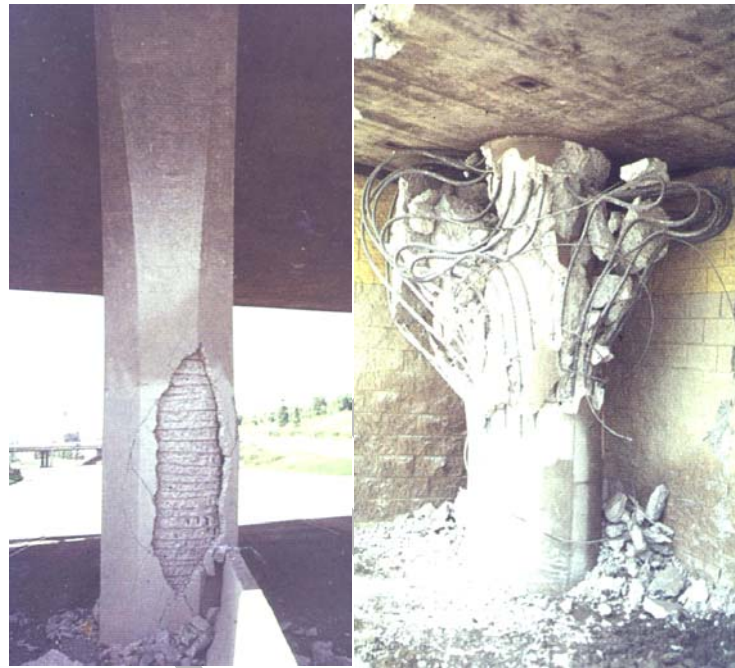
Fig. 1. Earthquake damage to a well-confined column and collapse of a poorly-confined column.

Recent earthquakes have highlighted the shortcomings of older design practices as it relates to reinforced concrete columns. There are primarily two major design deficiencies with the columns constructed prior to mid 1970s when the design codes were changed. The first problem is lack of adequate confinement steel; earlier codes called for 13-mm diameter ties to be placed at a spacing of 300 mm along the column height. This was independent of the column cross section and the number and size of the longitudinal bars. In the event of an earthquake, shortly after the cover or shell portion of the column cracks, the sparsely-spaced ties cannot provide sufficient confinement for the longitudinal bars and they buckle, leading to the collapse of the column. As shown in Fig. 1, while spirally reinforced columns that are well confined suffer minor damage, tied columns with little lateral confinement collapse under severe earthquake loading.

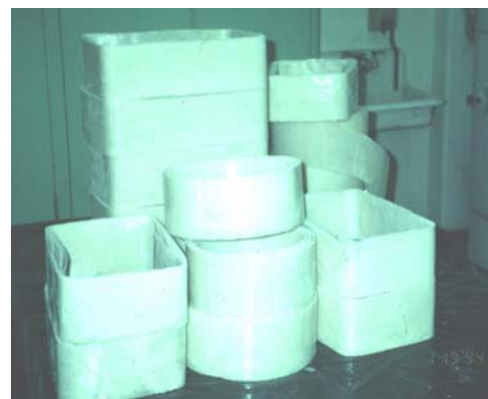
Fig. 4. FRP wraps (or straps) fabricated in the laboratory for the study.

The plastic hinging region for some of the columns were confined by Fiber Reinforced Polymer (FRP) wraps. E-glass fibers in the form of a unidirectional fabric were used in the construction of the composite wraps. The fabrication of the composite wraps involved laying flat a long strip of 150-mm wide unidirectional E-glass fabric and saturating it with polyester resin matrix. A layer of mylar sheet was then placed on the wet strip, and then the strip was rolled around a mandrel representing the size and shape of the column cross section and placed in an oven to cure. The mylar sheet was provided to prevent bonding of the composite strip (wrap) to itself while curing. The wet composite wrap was cured at 71 °C for 40 minutes. Figure 4 shows some of the finished FRP wraps or straps ready to be used in the repair or retrofit of columns.

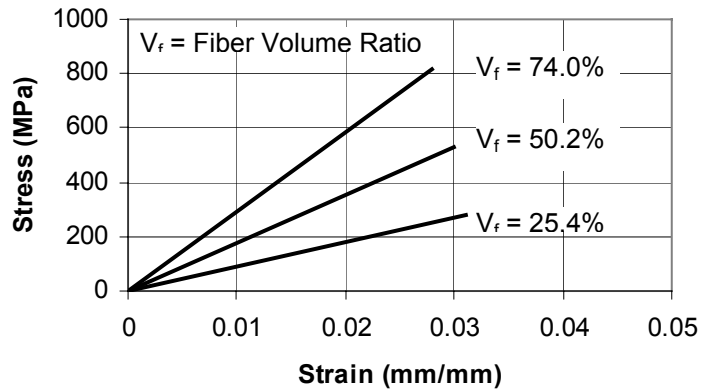
material parameters necessary for the analysis and design of test columns. As shown in Fig. 5, the stress-strain behavior of FRPs is linearly elastic to failure and depends on the fiber content. The fiber volume ratio shown in this figure is defined as the volume of fibers over the total volume of composite material. Three different fiber contents were tried for this study. A volume content of 50.2% was selected since it represents a fiber content that can be easily achieved in the field. Thus, the wraps were 0.8 mm thick and had a tensile strength of 532 MPa.

Fig. 5. Stress-strain behavior of E-glass FRPs.

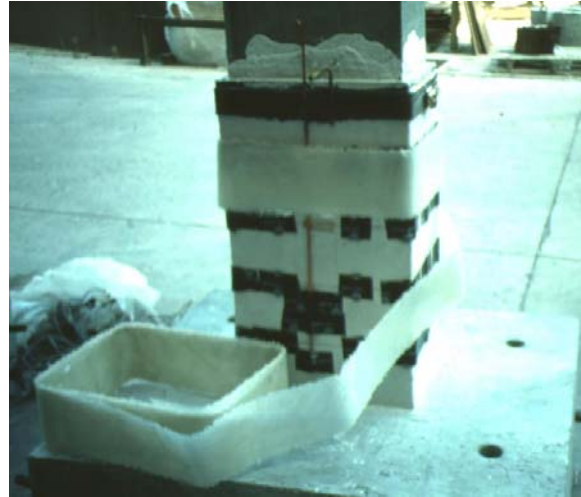
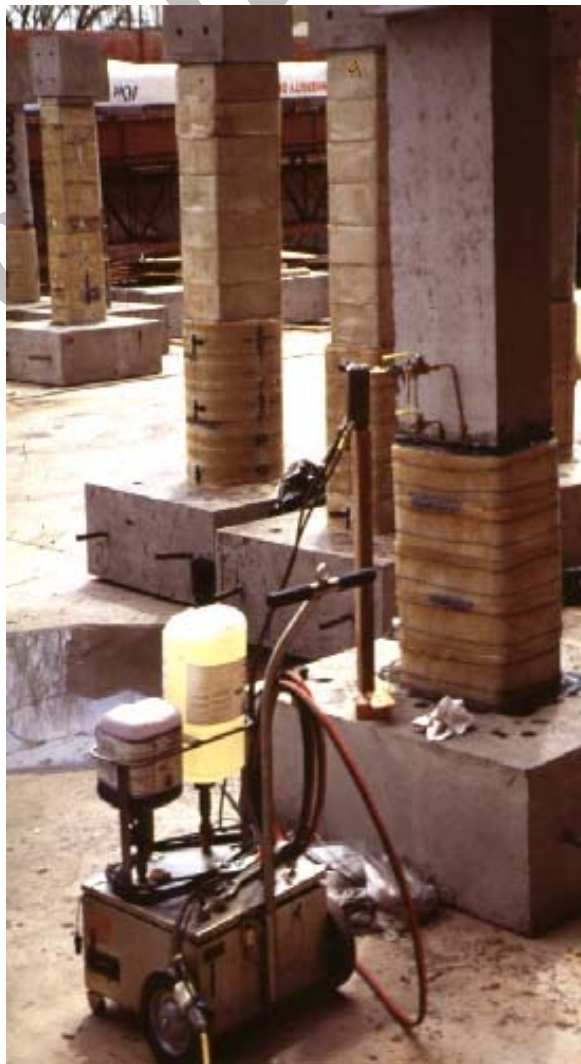
Fig. 6. Wrapping of FRP straps around columns and pressurizing for active confinement.

resisted by the FRP jacket. Thus, only beyond that point the FRP begins to apply a confining pressure to the column. Other specimens were repaired or retrofit using active confinement. In this case, the FRP straps are wrapped around the column and after the epoxy is cured, a resin is pressure injected into the gap between the FRP and concrete column (Fig. 6). This forces the resin into the micro cracks of the concrete and places the FRP in tension (similar to prestressing). During the initial stages of pressure injection, some of the epoxy would migrate up through the micro cracks and pores. Additional epoxy was injected to compensate for the loss of pressure due to this migration and to achieve a relative stable pressure. It is anticipated that this pressure could further drop with time as the epoxy migration would continue. Moreover, this pressure could further drop as a result of the creep of epoxy and the wrap. However, at these low levels of injection pressure, the contribution of the latter two to the loss of pressure was expected to be minimal.

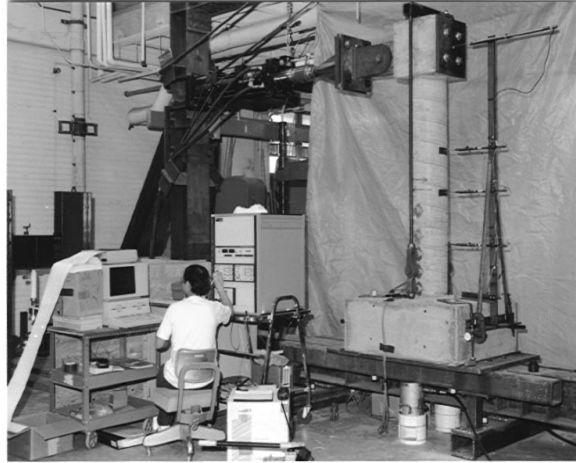
The specimens were tested in a steel reaction frame as show in Fig. 7. Two independent loading systems were used to apply the load to the specimens. The axial load of 445 kN was applied to the column by prestressing a pair of 25-mm diameter high-strength steel rods against the base of the test frame, which was bolted to the 900-mm thick concrete floor. This load was applied to simulate the vertical dead and live loads on the column. The magnitude of this load was determined based on the scale factor of 1/5 over the tributary area, resulting in a factor of  $1/5 \times 1/5 = 1/25$ . The prototype column had been designed for a gravity load of  $0.15A_g f'_c$  or 11,200 kN, which is equivalent to an axial load of 445 kN on the test columns. While maintaining this axial load constant, lateral loads were applied to the top of the specimen.

Fig. 7. Test setup.

computer controlled MTS  $\pm 490$  kN hydraulic actuator mounted on the reaction frame. The actuator was capable of moving the top of the specimen 125 mm in both positive and negative directions. A displacement of 125 mm corresponds to a ratio of lateral displacement to column height of approximately 7%. The load and displacement input history was broken into two phases. In the first four cycles of loading, the actuator was operated in the load-controlled mode. The maximum load in each cycle was gradually increased to that corresponding to the yield load of the specimen during the fourth cycle. Beyond that point, the loading was changed to the displacement-controlled mode for the remainder of the test. The displacement

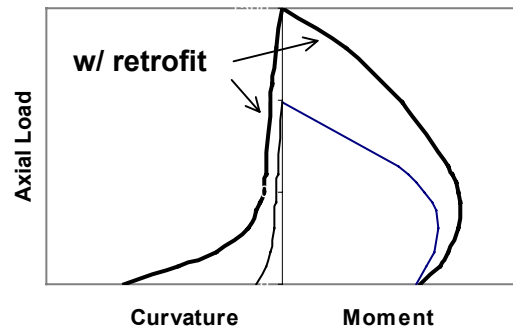
The interaction diagram for a reinforced concrete column is qualitatively shown in Fig. 9 with a light line. For seismic regions, not only the strength, but also the deformability of the column is of great interest. Thus, the P-M diagram shown here also includes a companion curvature diagram. As can be seen, in regions of high axial load, the curvature at failure is fairly small. For tension failure (i.e. below the balanced axial load), the curvature is larger and increases as the axial load is reduced towards zero. When a column is retrofit, a new P-M- $\phi$  diagram results as qualitatively depicted with heavier lines in Fig. 9.

Fig. 9. Comparison of P-M- $\phi$  diagrams for R/C columns with and without retrofit.

Once the stress-strain diagram for the confined concrete is determined, the points on a column interaction diagram can be calculated. For a given value of strain in the extreme fiber of concrete, the depth to the neutral axis can be assumed and the strains at any point on the cross section can be calculated assuming that strains vary linearly. From the strains, stresses in concrete and steel and the corresponding force in these elements can be calculated. The difference between the internal compression and tension resultants is the axial load acting on the column. The moments of the internal forces can also be calculated. Curvature of the section is calculated by dividing the maximum concrete strain by the depth to the neutral axis. This procedure can be repeated and each set of calculations leads to a set of points to be plotted on the P-M- $\phi$  diagram.

There are a couple of points regarding the interaction diagram of the retrofit columns that deserve special attention. First, because the fibers in the FRP jackets are oriented in the horizontal (i.e. hoop) direction, they do not increase the bending capacity of the column much. This is important because increase in the bending capacity of the column may make the column stronger than the footing, and in a potential future earthquake, the footing may fail. Due to access limitations, repair of footings is more difficult and less desirable than that of columns. The second advantage to note

is the significant increase in ductility or curvature of the column. This is particularly true for regions of low axial loads that are more significant in practice. In fact, the primary interest in retrofit of most columns is to increase their ductility at low axial load levels with little increase in strength. Both of these objectives are readily achieved by use of FRP jackets.
