Original Article

Influence of Er,Cr:YSGG Laser Surface Treatments on Micro Push-Out Bond Strength of Fiber Posts to Composite Resin Core Materials

Cite this article as: Ghavami-Lahiji M, Benedicenti S, Karimian R, Shahabi S. Influence of Er,Cr:YSGG Laser Surface Treatments on Micro Push-Out Bond Strength of Fiber Posts to Composite Resin Core Materials. J Dent Biomater, 2018;5(1):533-542.

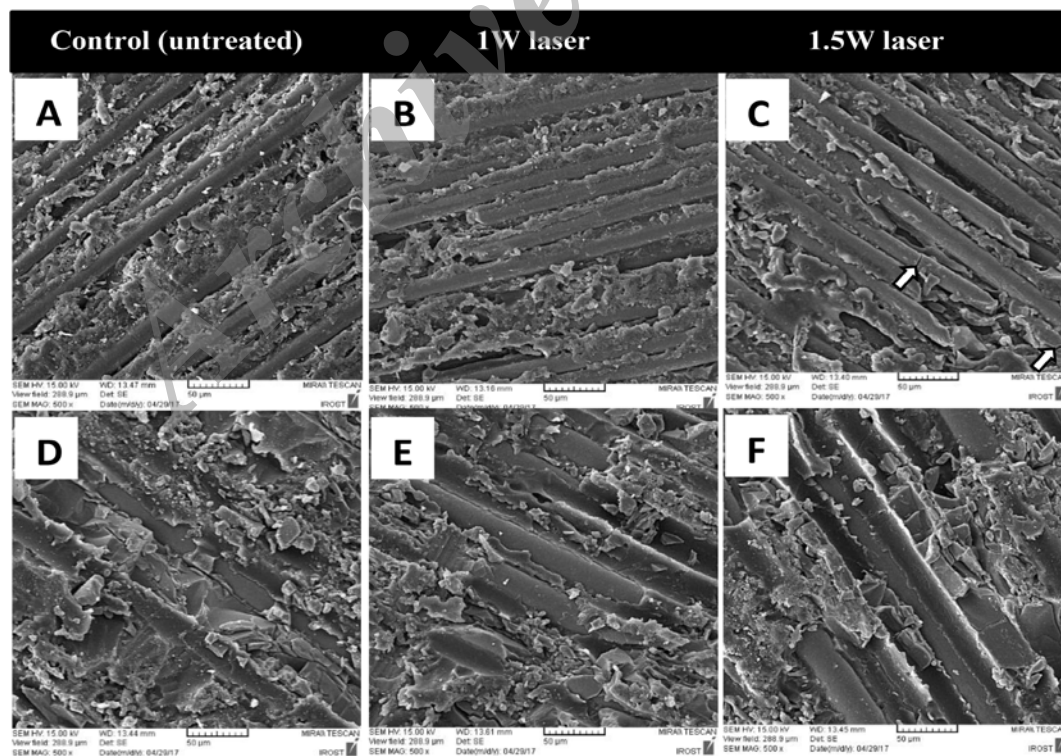
Figure 2: Field emission scanning electron microscopy (FE-SEM) micrographs of glass fiber post surface after different treatments at 500x magnification. (A-C) Exacto post, (D-F) White post DC. The differences in diameter of the fiber posts are clearly shown in the pictures. White post DC fibers are thicker than the Exacto fibers. White arrows show the cracked areas on the surface of the fiber post

post DC groups. However, several micro-cracks were found in Exacto posts irradiated with 1.5W Er,Cr:YSGG (Figure 2). Mode of failure after the push-out test revealed that the mixed failure mode had the most failure mode of all groups (Table 3).

Based on the results of the present study, we rejected the first null hypothesis. The results of FE-SEM micrographs revealed that the Er,Cr:YSGG laser caused surface changes in the fiber posts because the laser partially removed the cross-linked epoxy resin matrix. Therefore, the surface roughness and porosities of the post surface increased. This might provide better penetration of resin to the porosities and micromechanical locking would improve the retention of core materials. The second null hypothesis was partially rejected. In the White post DC groups as laser irradiation had no significant effect on the micro push-out bond strength. However, the 1.5W Er,Cr:YSGG laser irradiation of the Exacto posts significantly reduced bond strength. The micro push-out bond strength is classified as shear bond strength test.

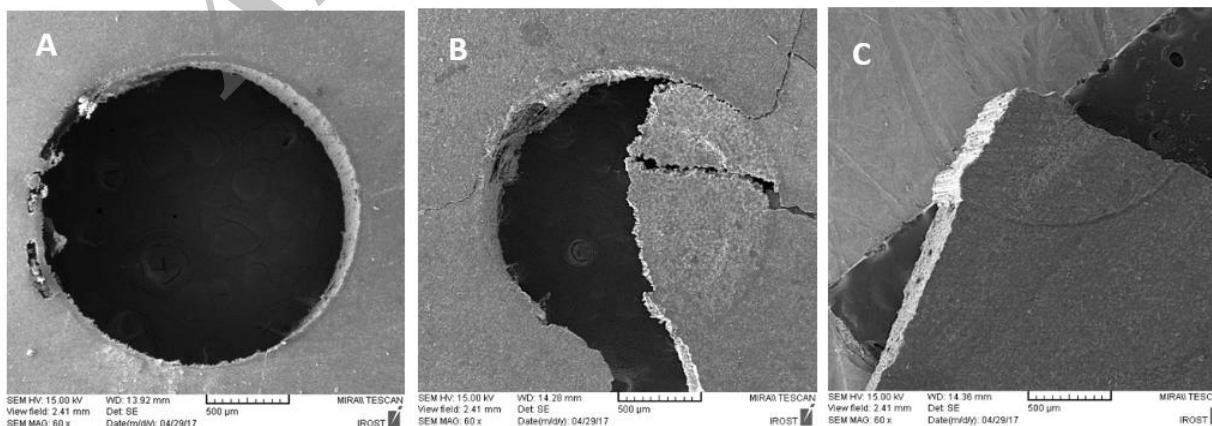
Figure 4: Adhesive (A), mixed (B), and cohesive failure (C) within post and core under field emission scanning electron microscopy (FE-SEM)
